Tree Risk Assessment

11th November 2024

Example

Treescapescapes

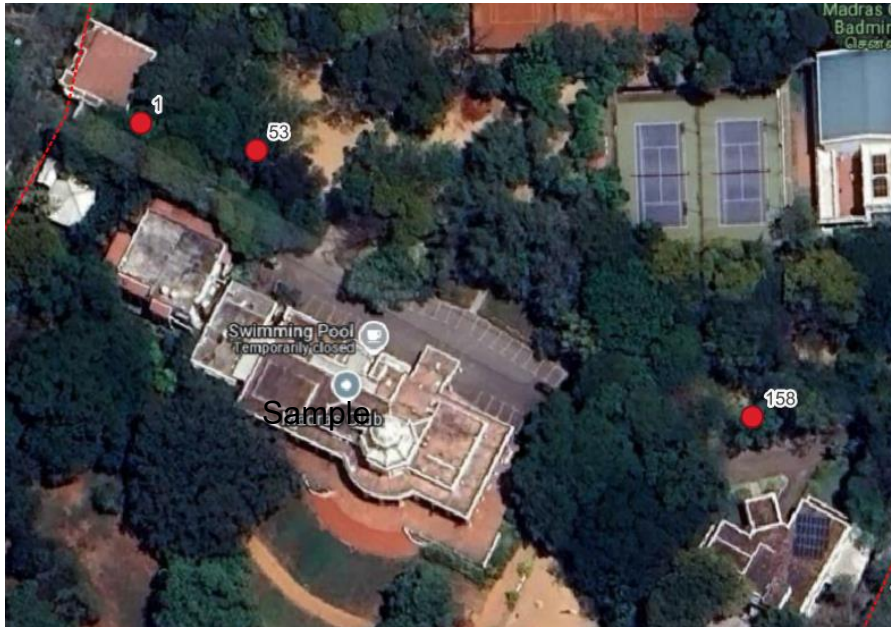
1. Three trees are recommended to have advanced assessments as their structural condition appears somewhat precarious but, as they are old specimens, due consideration is recommended to be taken before drastically reducing their height, felling or keeping as is. Image of the location of the trees to be further assessed below.

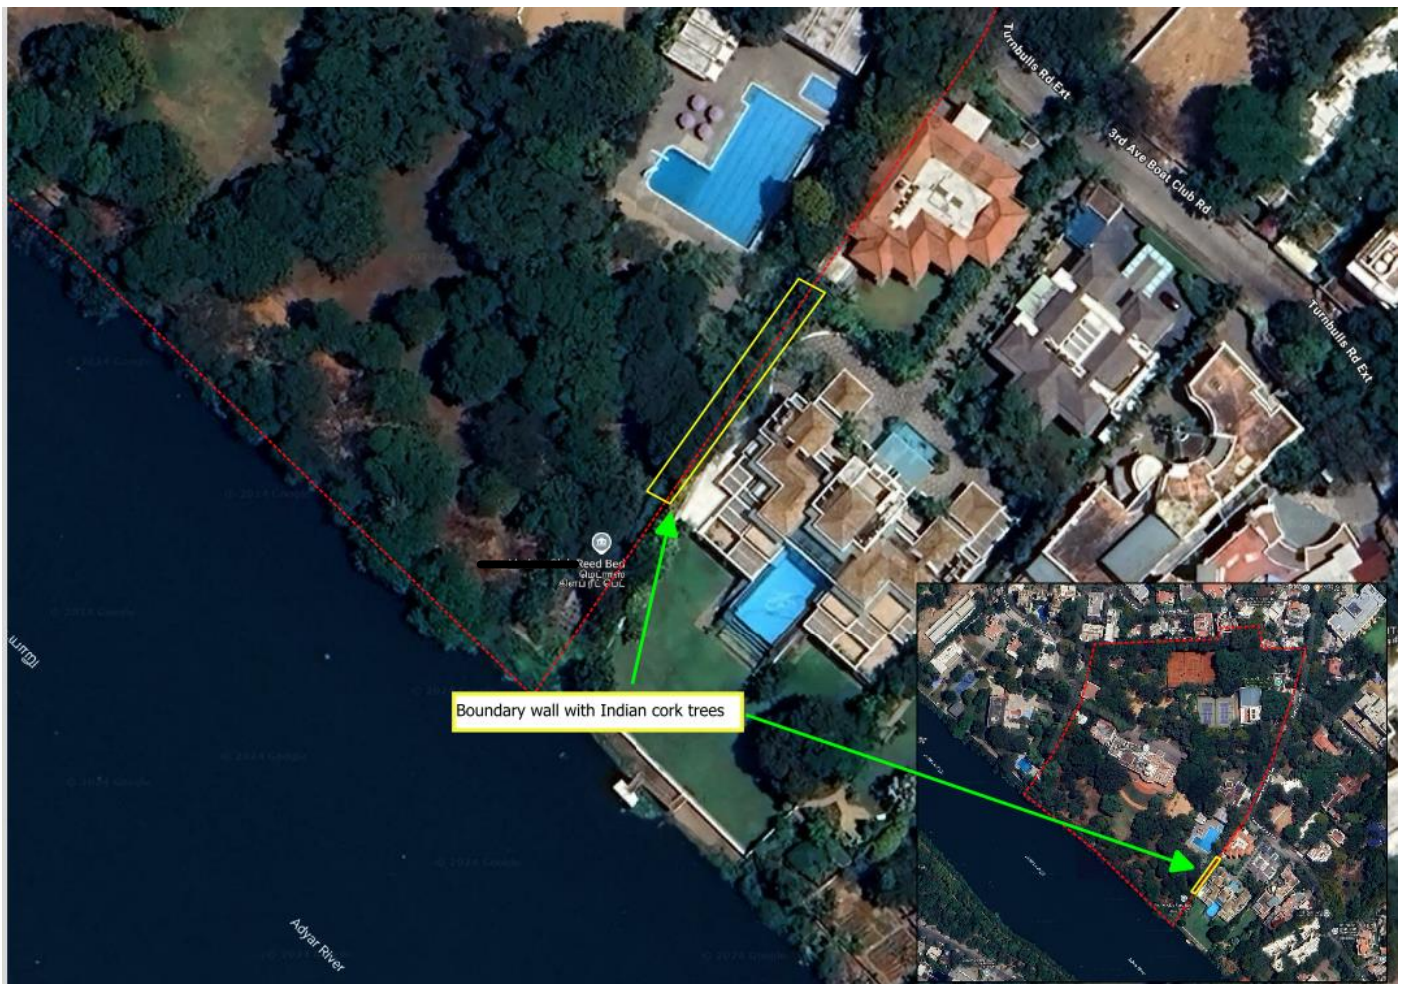
6. It is important that nothing is stacked at the base of or leaning on to the stem of trees, including leaves, as this can lead to decay.
7. Consider removing the Indian cork trees on the boundary wall (see below image) as they are pushing against it and may damage/topple it in the future. Consider planting other trees farther away from the wall (we can provide recommendations if required).

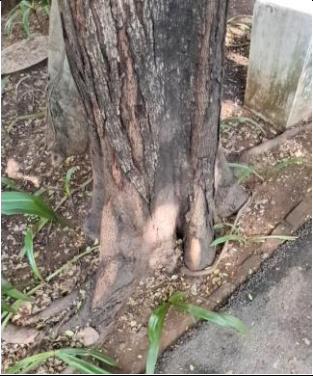
Id Number	Scientific name	Common Name	Life Stage	Height	Diameter	Spread	Health	Structure	Comments	Recommendations	Work Priority	Re-inspection	Pictures
16	Peltophorum pterocarpum	Copper Pod	M.A.	17	43	14	Good	Fair	Intertwining stems. Too late to repair. Small girdling root at base.	Cut small girdling root at base	Low

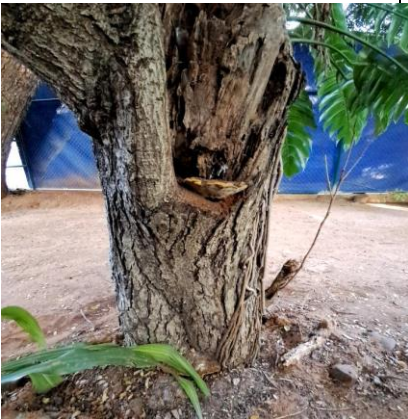
37	Peltophorum pterocarpum	Copper Pod	M.A.	12	40	14	Good	Poor	Several large pruning wounds near the base and in the canopy. A few dead branches present.	Remove dead branches	Low	1 Year	
38	Peltophorum pterocarpum	Copper Pod	M.A.	9	60	14	Good	Fair	Large pruning wound near the base and in canopy. Fungus fruiting bodies at and near base.	Monitor.	N/A	1 Year

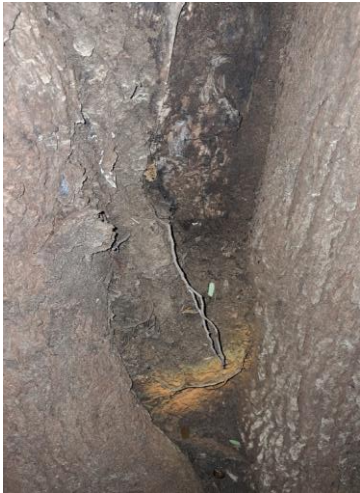
39	Albizia saman	Rain tree	V	20	142	36	Good	Fair	Several old pruning wounds present. Nothing worrisome. Epicormic shoots present where branches have been pruned recently.	Remove some epicormic shoots but keep those with good structure.	Low		
40	Tamarindus indica	Tamarind tree	M	18	70	16	Good	Poor	Large cavity near base with fruiting body.	Monitor	N/A	1 Year

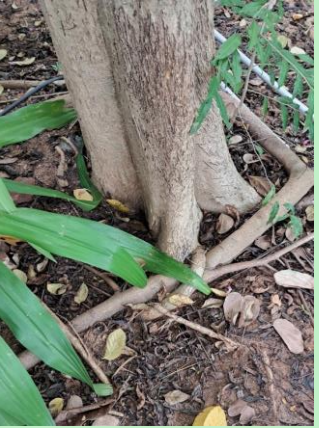
Id Number	Scientific name	Common Name	Life Stage	Height	Diameter	Spread	Health	Structure	Comments	Recommendations	Work Priority	Re-inspection	Pictures
186	Peltophorum pterocarpum	Copper Pod	M.A.	21	63	16	Good	Fair	Concrete at base is too close to the tree. Branches have been pruned away from the buildings in non-methodical ways. Numerous epicormic shoots.	Give at least 20cm clearance from stem with concrete at base. Prune away from buildings.	Low		
187	Libidibia coriaria	Butterfly tree	M	8	34	8	Good	Poor	Tree is supported by adjacent buildings.		N/A		
188	Peltophorum pterocarpum	Copper Pod	M.A.	20	69	15	Good	Fair	Crossing branch at 7 meters. Numerous pruning wounds. Fungus fruiting bodies at base and lower stem. Weakly attached branch, it seems, at 10 meters on NW side.	Remove crossing branch at 7 meters. Inspect weakly attached branch at 10 meters. Monitor	High	1 Year	
189	Spathodea campanulata	African tulip tree	Y	14	33	11	Good	Good	Ficus root is growing around the tree at the base.	Prune ficus root around the tree.	Low

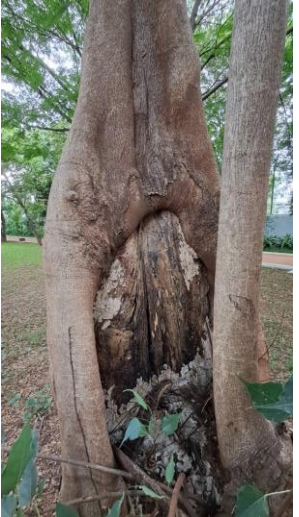
Id Number	Scientific name	Common Name	Life Stage	Height	Diameter	Spread	Health	Structure	Comments	Recommendations	Work Priority	Re-inspection	Pictures
314	Delonix regia	Gulmohar	M.A.	11	40	9	Good	Fair	Old wound where the codominant branch failed but the tree has resolidified its structure since.		N/A
